# Manhole Inspection Summary

Manhole # S09KK1010MH

**Location** Address: **3348 VIRGINIA AVE**

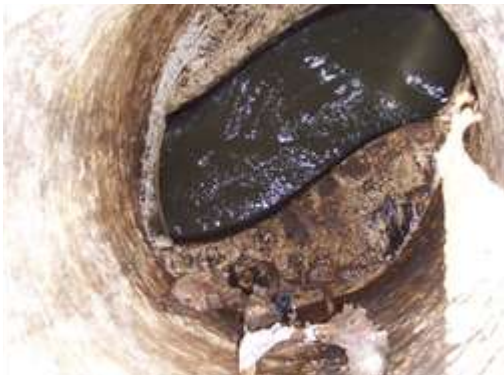
Defect 1

Count: **4** Missing: **1** ☒ **Corroded**

☒ **Evidence Of Surcharge**

Depth: **7.5** (ft.) ☐ Active Surcharge Present

CORRODED STEPS AND SURCHARGE  
EVIDENCE

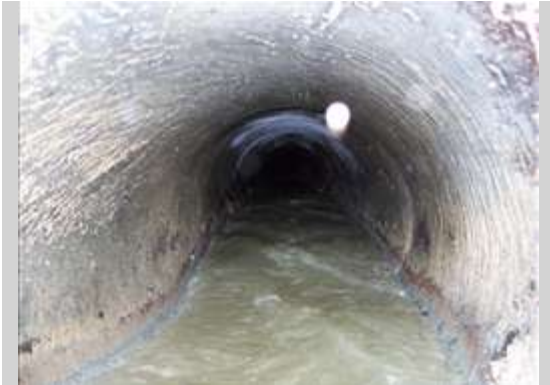
12 O'Clock Outflow

18 in. Circular Gravity Sewer  
Pipe Out @ 12 O'Clock

Pipe Height: **18** (in.) Rod and Bar (Angled)  
Pipe Material: **PVC** ☐ Pipe Lined  
Invert Depth: **9.43** (ft.) Flow Characteristics: **Fast**  
Deposits: ☒ None ☐ Mud ☐ Sludge ☐ Debris ☐ Grease  
Silt Depth: (in.) Deposits Extent:  
Infiltration: **None** Pipe Seal Cond: **Sound**

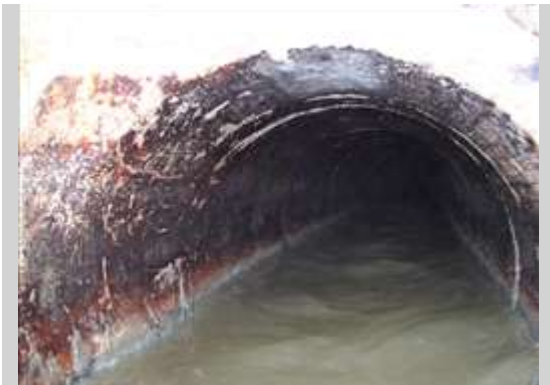
7 O'Clock Inflow

18 in. Circular Gravity Sewer  
Pipe In @ 6 O'Clock

Pipe Height: **18** (in.) Rod and Bar (Angled)  
Pipe Material: **PVC** ☐ Pipe Lined  
Invert Depth: **9.40** (ft.) Flow Characteristics: **Fast**  
Deposits: ☒ None ☐ Mud ☐ Sludge ☐ Debris ☐ Grease  
Silt Depth: (in.) Deposits Extent:  
Infiltration: **None** Pipe Seal Cond: **Sound**
